HIGHWAY ACCIDENT REPORT

**COLLAPSE OF U. S. 35 HIGHWAY BRIDGE,
POINT PLEASANT, WEST VIRGINIA
DECEMBER 15, 1967**

**NATIONAL TRANSPORTATION SAFETY BOARD
Washington, D. C. 20591
REPORT NUMBER: NTSB-HAR-71-1**

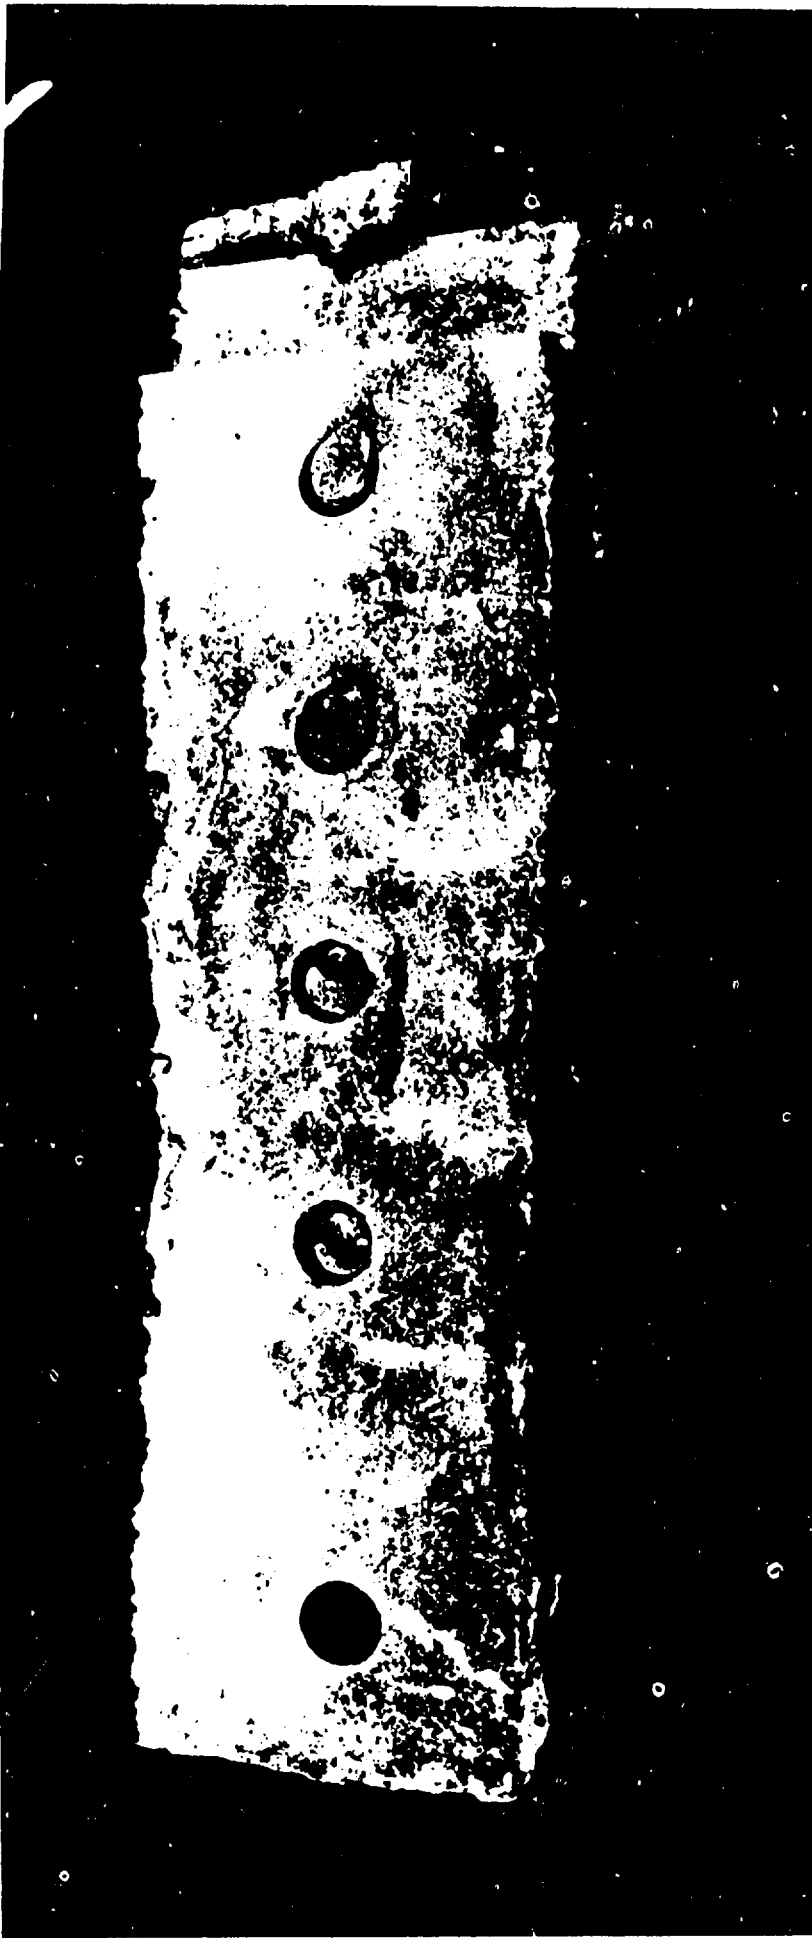
Figure 14 shows the fractures in the group of rivets which fastened this channel to the outboard or north gusset plate. The failure plane was at the interface between the channel flange and the gusset plate. Rivets A and B, which were the two lowest rivets in the joint show rather unusual fractures. The metallurgical examination indicates that the fractures originated in small discontinuities at the outside surface of the rivets in areas that exhibited significant decarburization. Fracture was by cleavage in these initial zones, but by mixture

Figure 14 - Rivet Fractures in Hanger Connection at U13 N (NBS Photo)

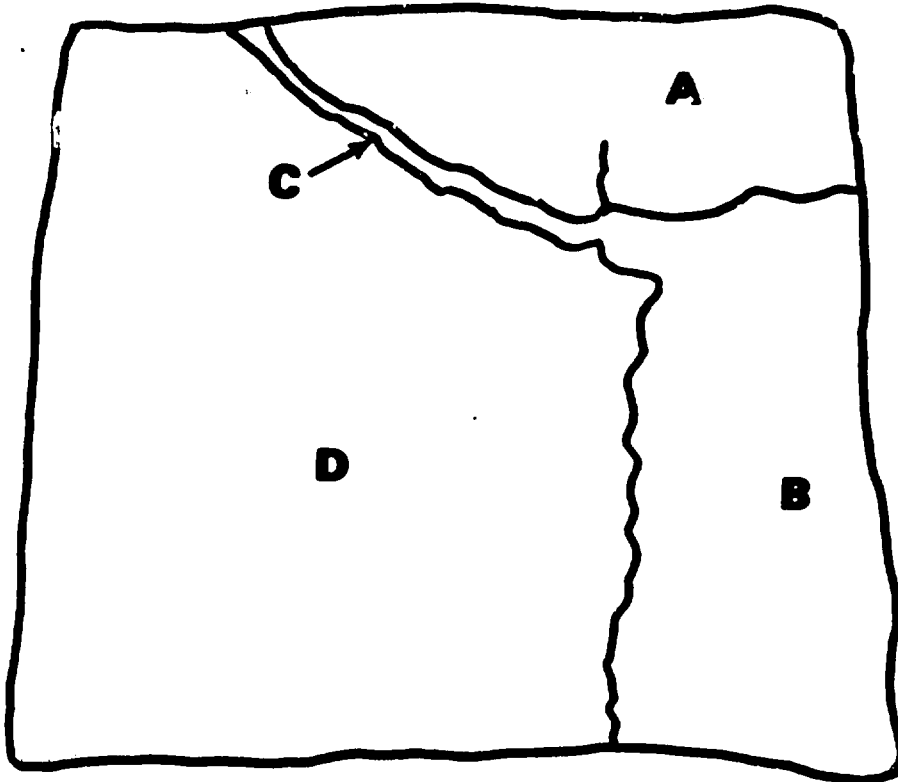
Figure 24b - Fracture Regions in Freshly Opened Crack in Eyebar Steel
(U. S. Steel Photo)
