HIGHWAY ACCIDENT REPORT

**COLLAPSE OF U. S. 35 HIGHWAY BRIDGE,
POINT PLEASANT, WEST VIRGINIA
DECEMBER 15, 1967**

**NATIONAL TRANSPORTATION SAFETY BOARD
Washington, D. C. 20591
REPORT NUMBER: NTSB-HAR-71-1**

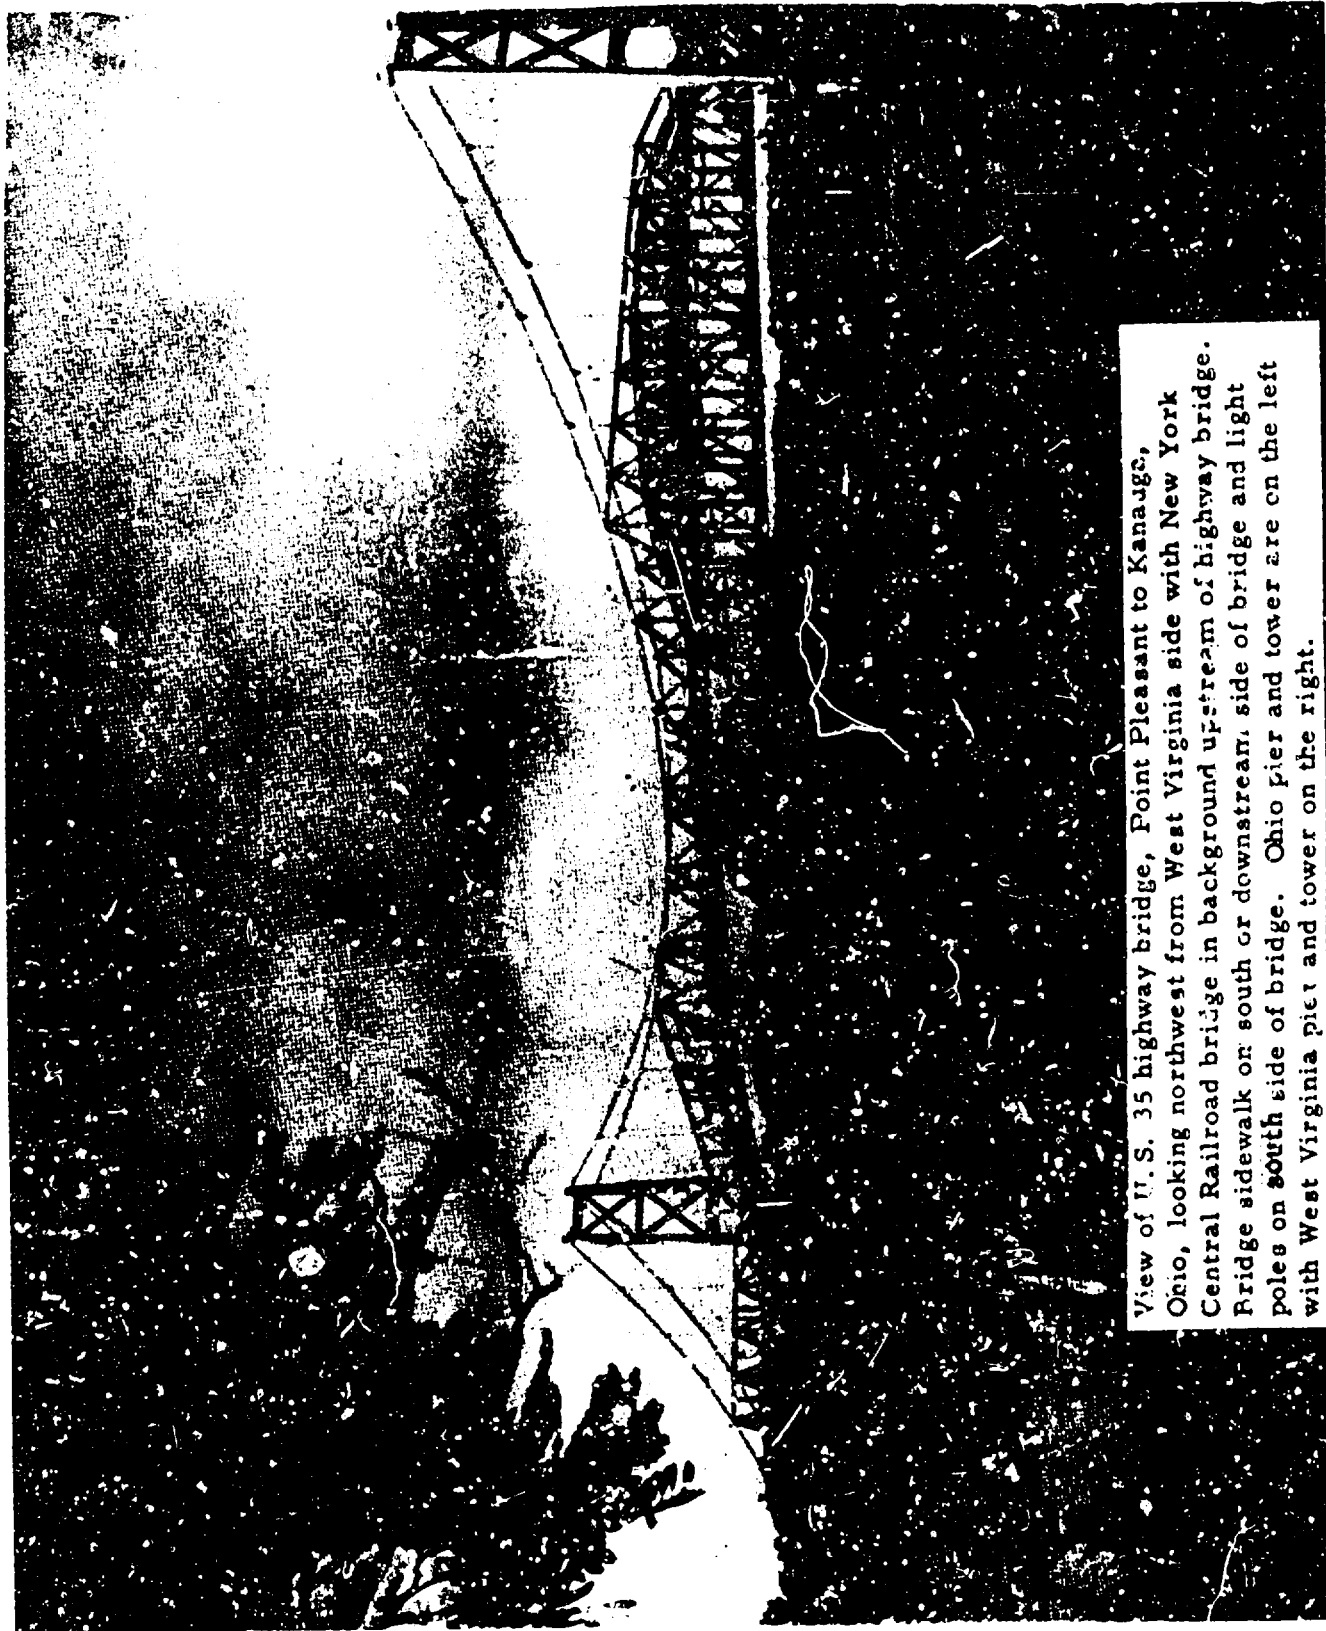
Figure 1

View of U. S. 35 highway bridge, Point Pleasant to Kanawgo, Ohio, looking northwest from West Virginia side with New York Central Railroad bridge in background upstream of highway bridge. Bridge sidewalk on south or downstream side of bridge and light poles on south side of bridge. Ohio pier and tower are on the left with West Virginia pier and tower on the right.

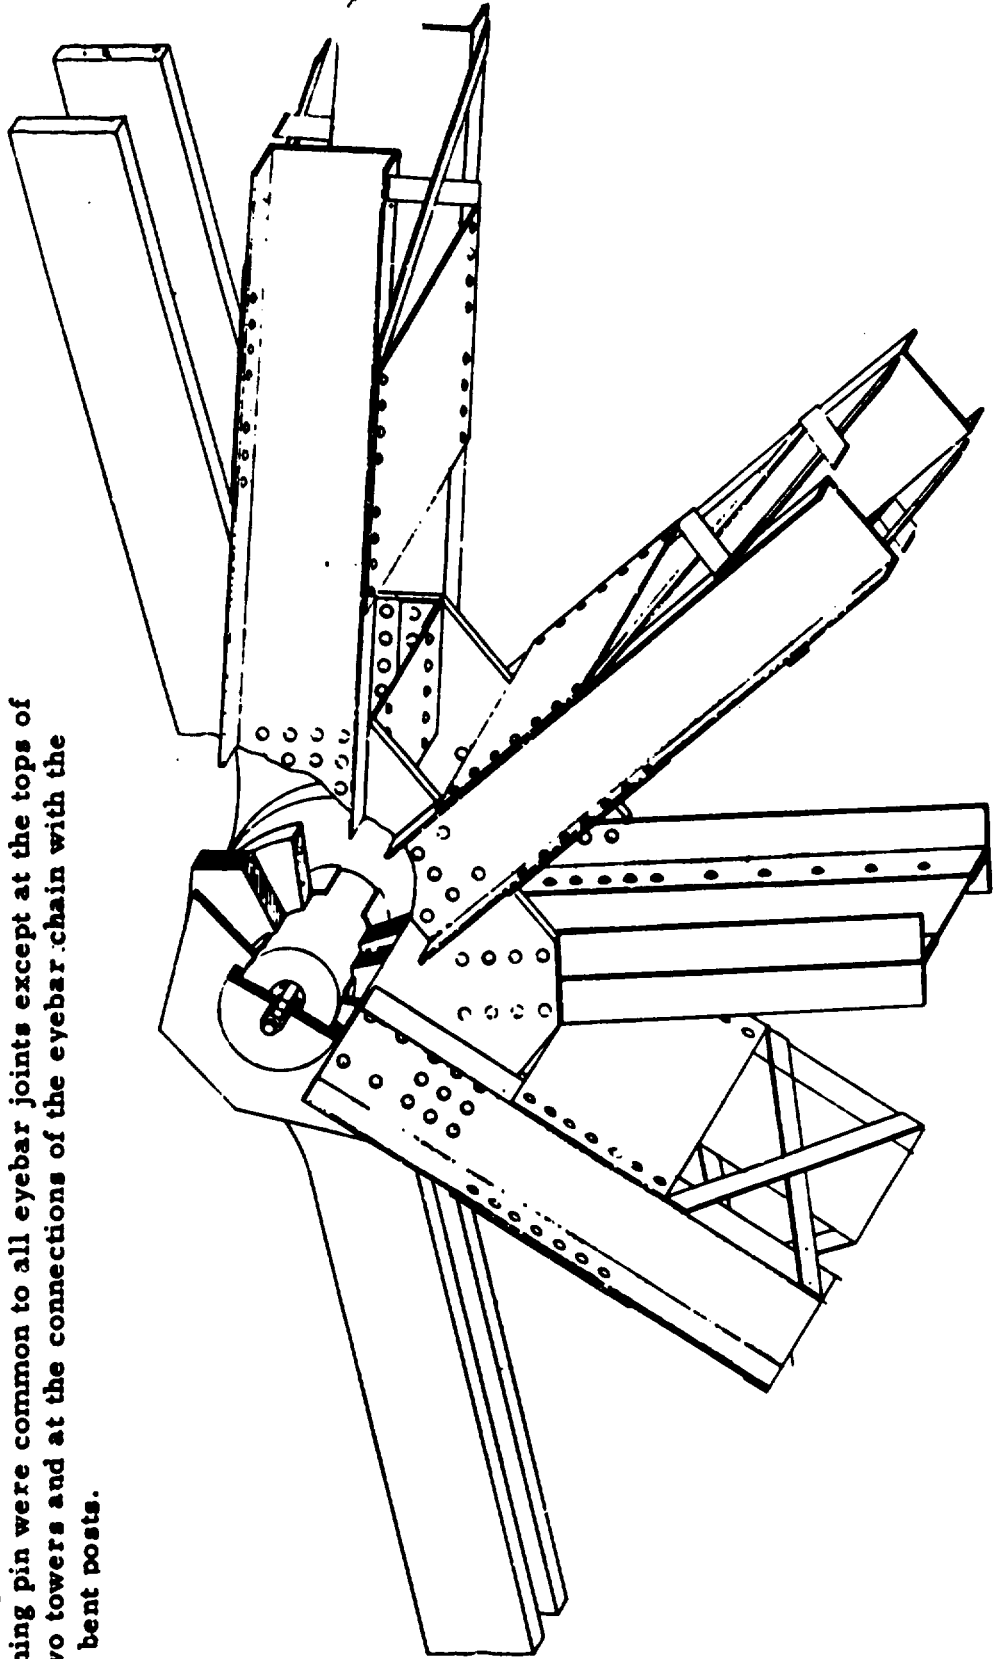
PLATE 1

Detailed diagram of construction of joint U7 of the north truss of the Ohio side span showing the joint pin, the two sets of eyebars, gusset plates attaching members of the north truss to the eyebar joint, retaining plate and the retaining pin which was inserted through a concentric hole in the joint pin and which was installed with two nuts on either end of the retaining pin. The makeup of the retaining pin, retainer plates and the use of double nuts on each end of the retaining pin were common to all eyebar joints except at the tops of the two towers and at the connections of the eyebar chain with the chain bent posts.

Figure 2b - Typical Detail of Truss to Chain Connection.

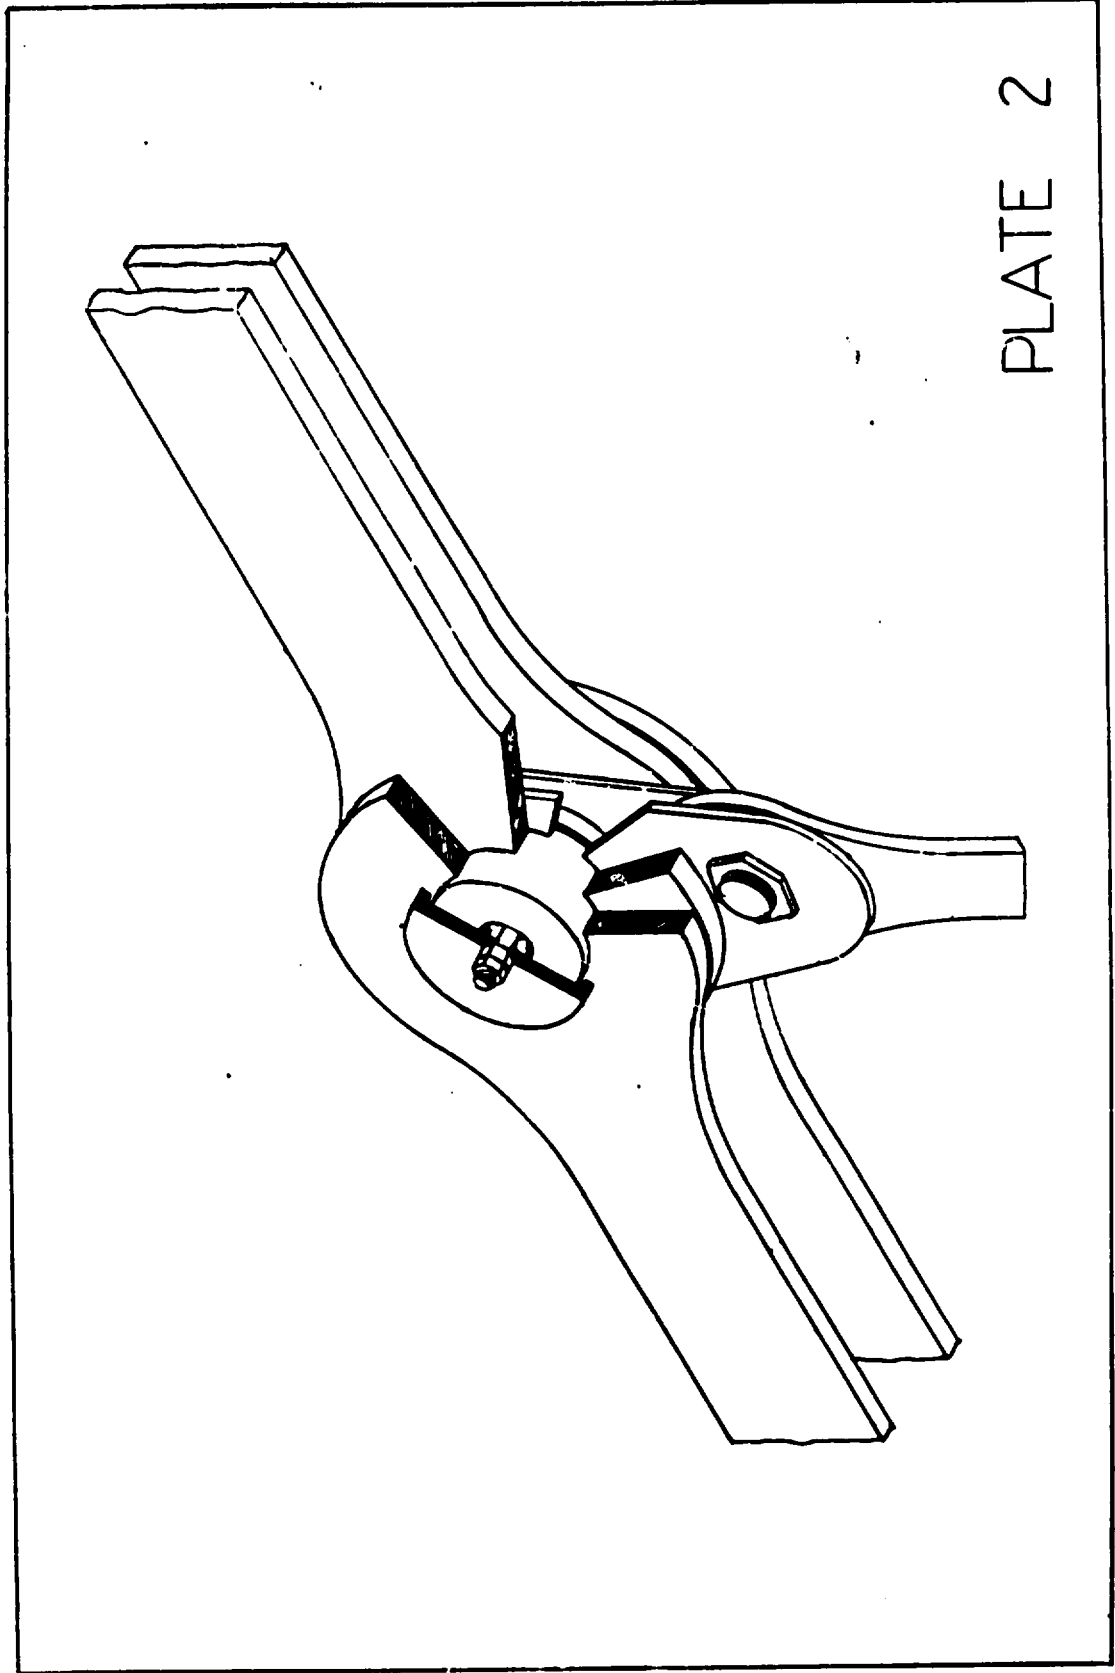
PLATE 2

Typical eyebar chain joint for portions of the eyebar chain where the chain was not framed into truss members. Note hanger strap and strap plates in the center of photograph. The strap plate was connected to the top chord of truss members vertically below the eyebar joint. This plate shows makeup of joint C13 north.

Figure 2c - Typical Detail of Eyebar Chain and Hanger Connection.

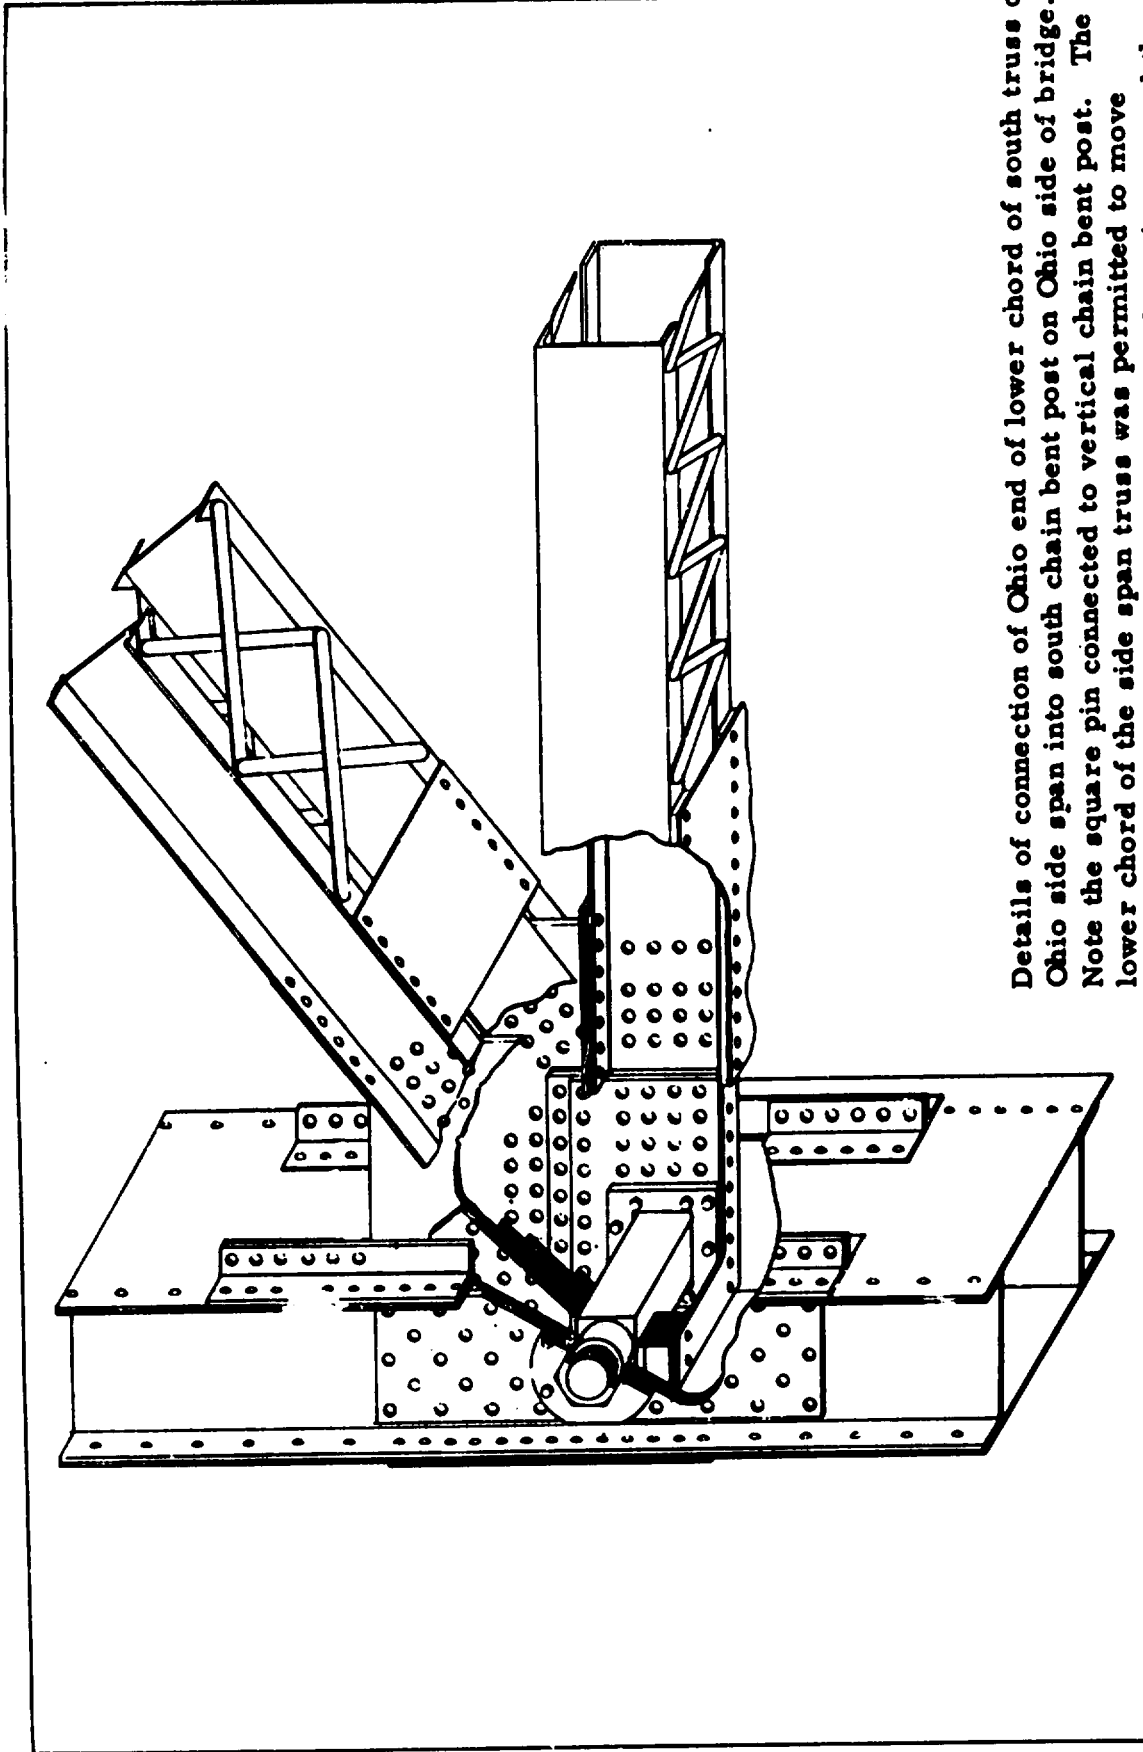
Figure 2d - Detail of Expansion Joint of Connection of Truss to Chain Bent Post.

Details of connection of Ohio end of lower chord of south truss of Ohio side span into south chain bent post on Ohio side of bridge. Note the square pin connected to vertical chain bent post. The lower chord of the side span truss was permitted to move longitudinally through provision of a slotted section around the square pin to equalize expansion and contraction of the bridge due to temperature changes and changes in live load. The detail shown was that used to connect the lower chords of both trusses of the two side spans into the four chain bent posts in the bridge.

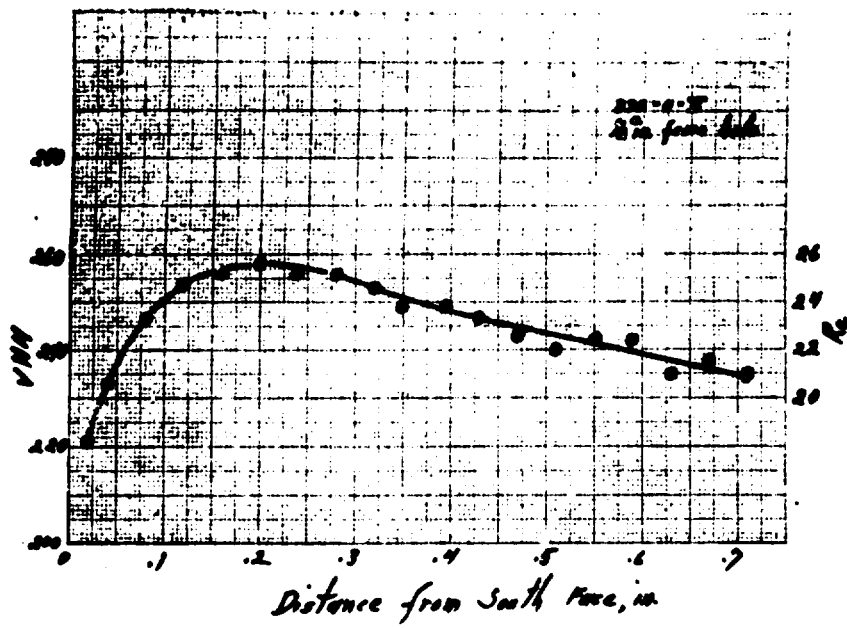
(2) The heat treatment which consisted of quenching in water from the austenitizing temperature (approximately 1600°F.) and tempering from between 1150 and 1200°F. produced a non-homogeneous micro-structure. It may therefore be characterized as a "slack-quenched" steel in which martensite was formed in a layer 1/4" to 3/8" thick adjacent to the surfaces and a ferrite-pearlite structure was formed in the interior. The outer 1/16 to 1/3-inch of the martensite layer was heavily decarburized. These facts were confirmed by hardness profiles taken through the thickness of the bar, with results as indicated in Figure 6.

Figure 6 - Variation of Hardness through Thickness of Eyebar Materials.
(NBS Photo)

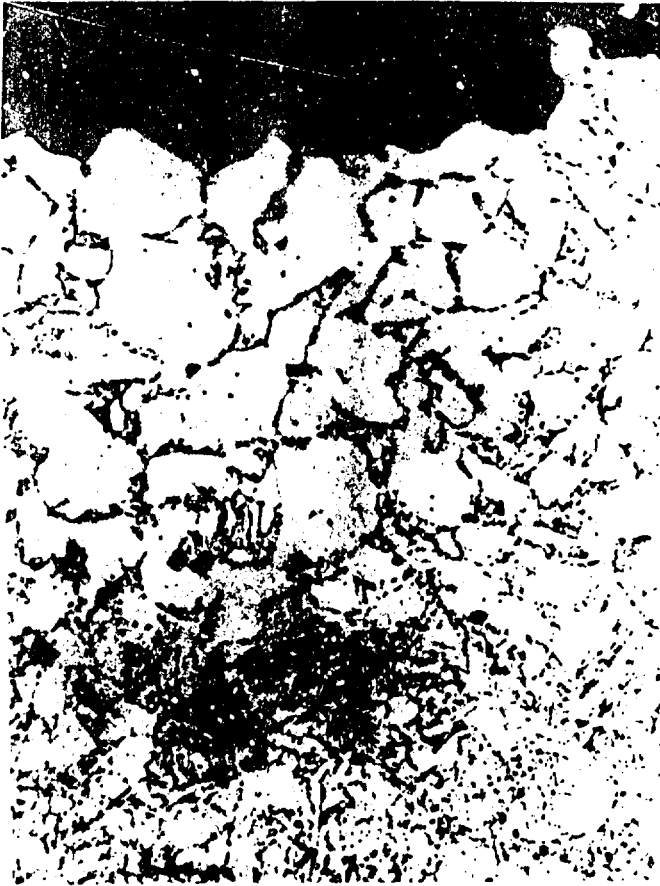
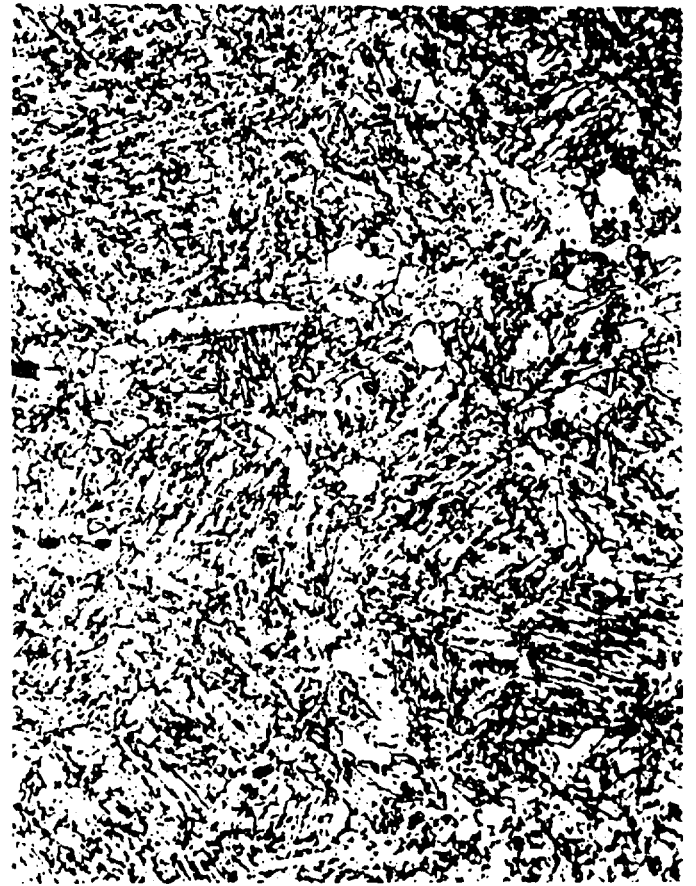
Figure 8 - Micro Structure of Eyebar Material (NBS Photos)

(a) Outer Surface

(b) Martensite at 0.2" depth

(c) Interior

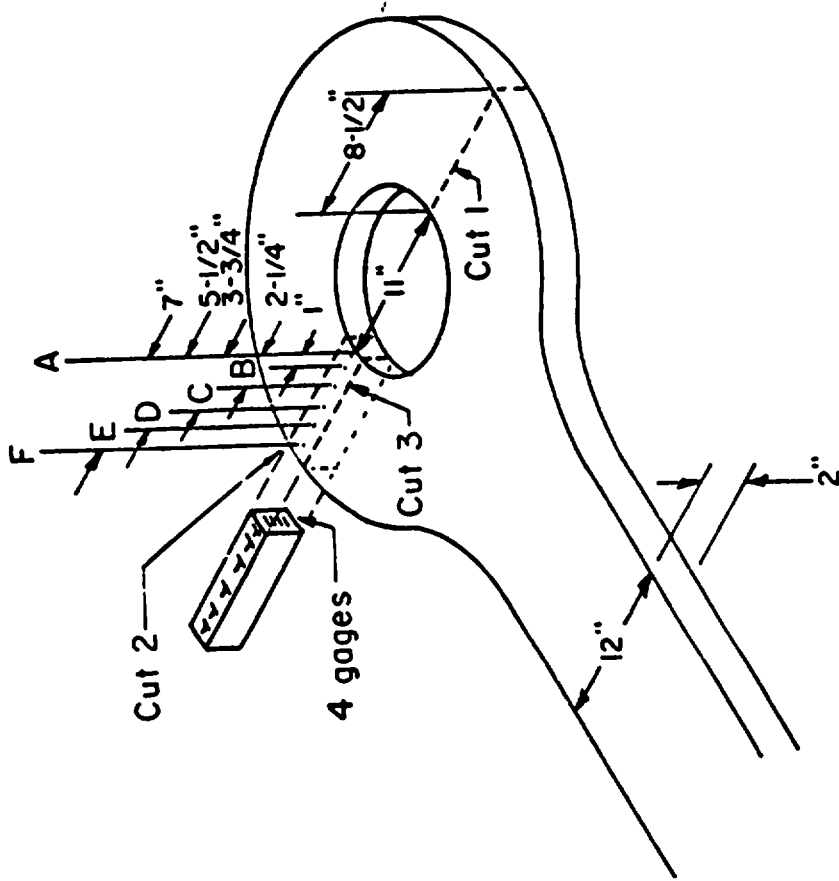
Figure 15 - EYEBAR WITH GAGE LOCATIONS AND INITIAL CUT LINES

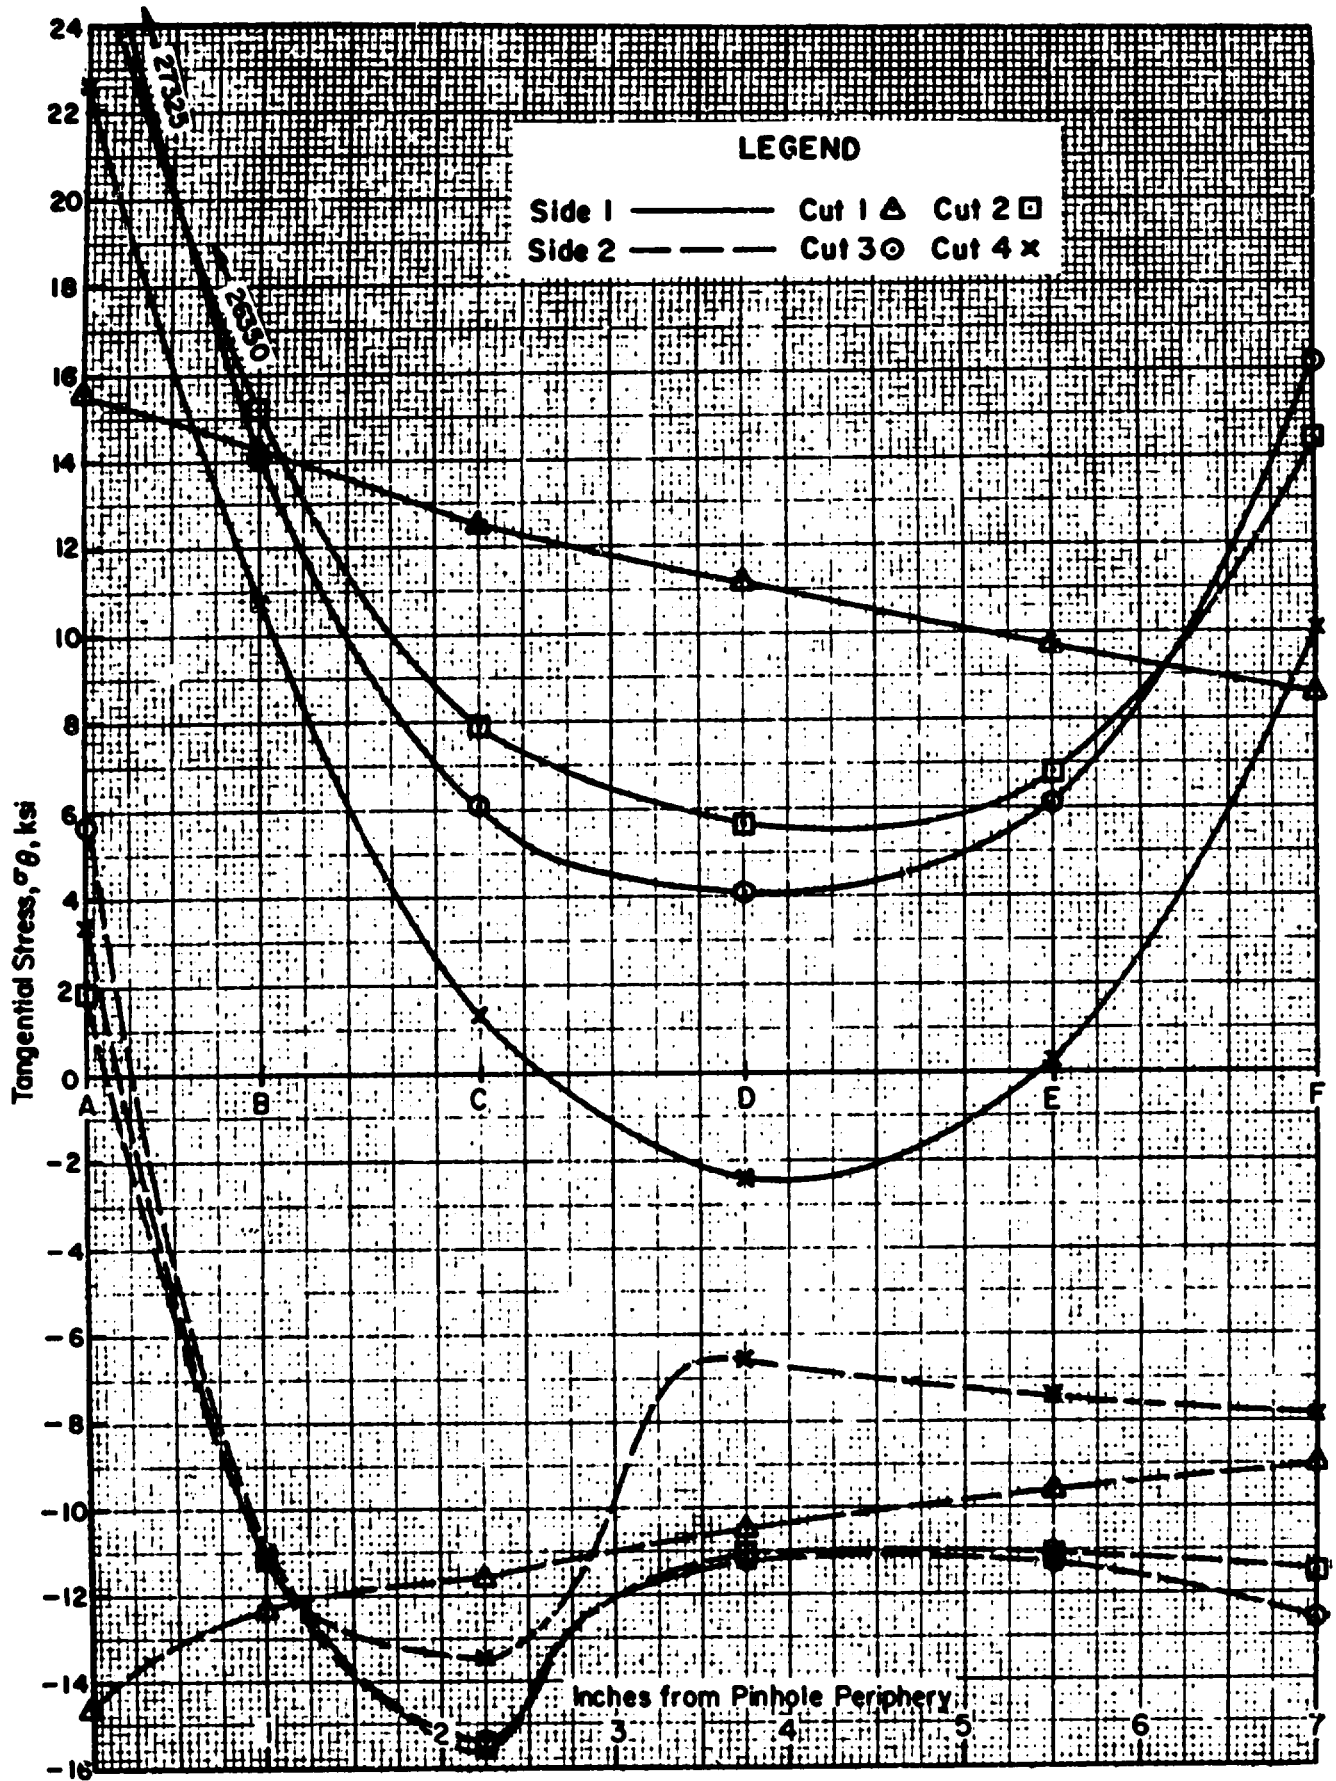
material through the thickness of this slice (See Figure 15). In general the results after the initial cuts (See Figure 16) show that residual stresses existed at the edge of the pinhole which were as high as 27,325 lbs. per square inch, with marked differences between the residual stresses at the two faces of the bar. The patterns of residual stress through the thickness were quite complex (See Figure 17) and in general the magnitudes were highest in the sections closest to the pinhole, indicating that stresses in excess of the yield strength of the material had existed at this point at some time during the life of the structure.

Figure 16 - CIRCUMFERENTIAL STRESS CONTOURS FOR INITIAL CUTS, SPECIMEN B-17

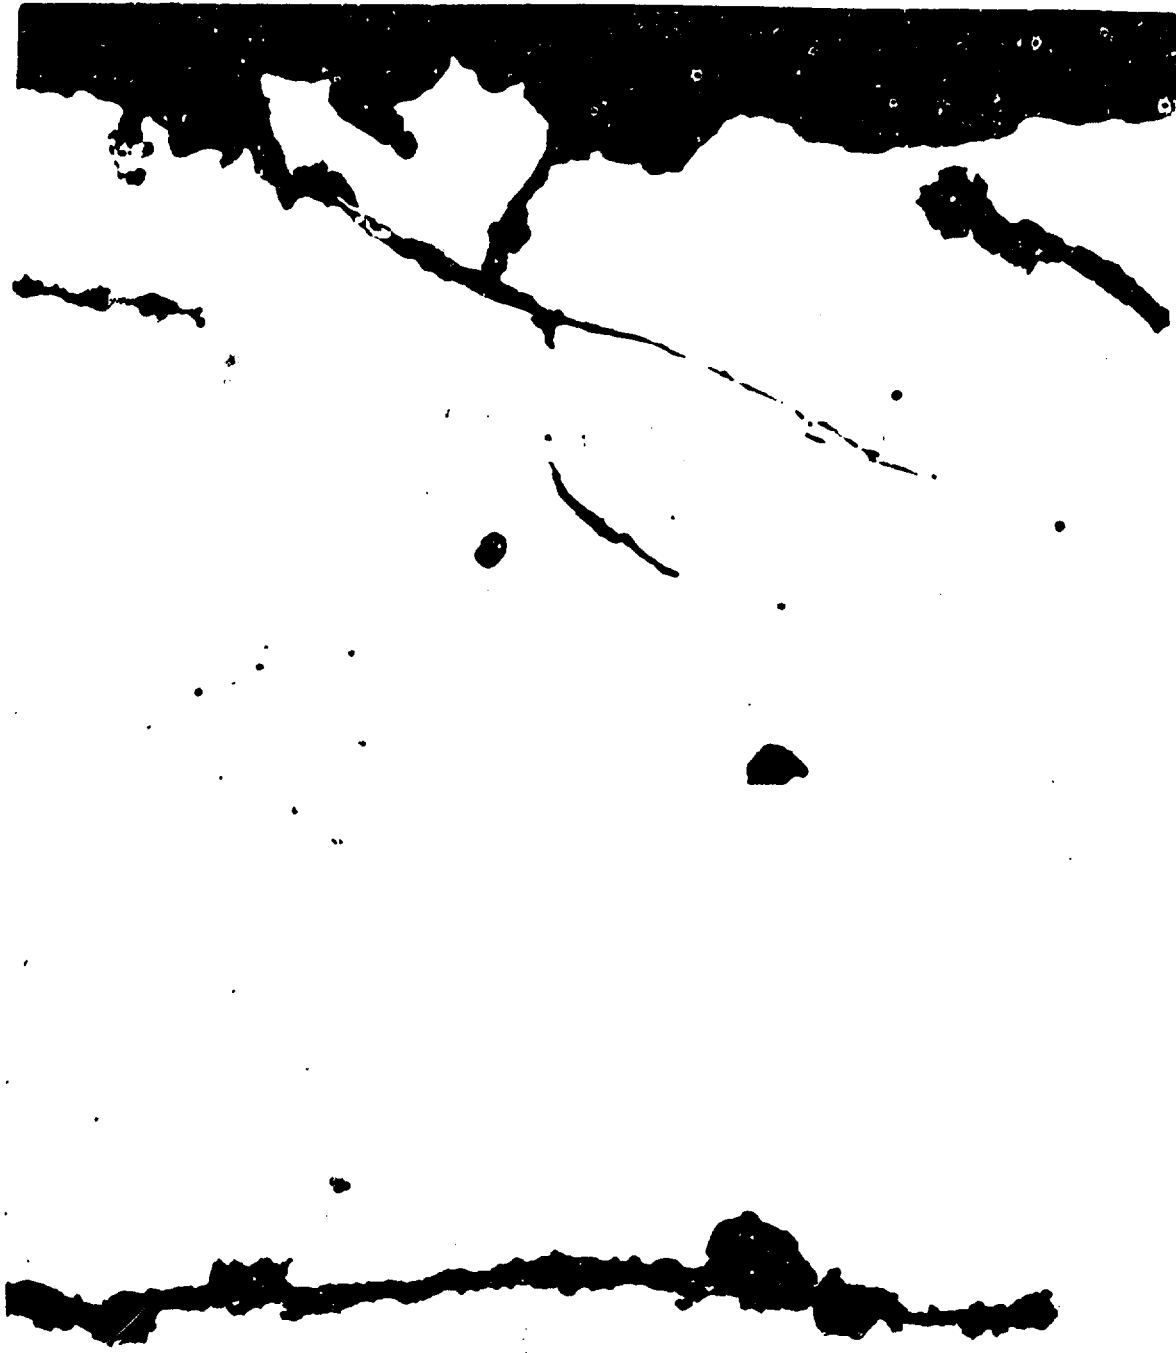
(a) Secondary Crack Tip

(b) Branch Crack along Main Fracture

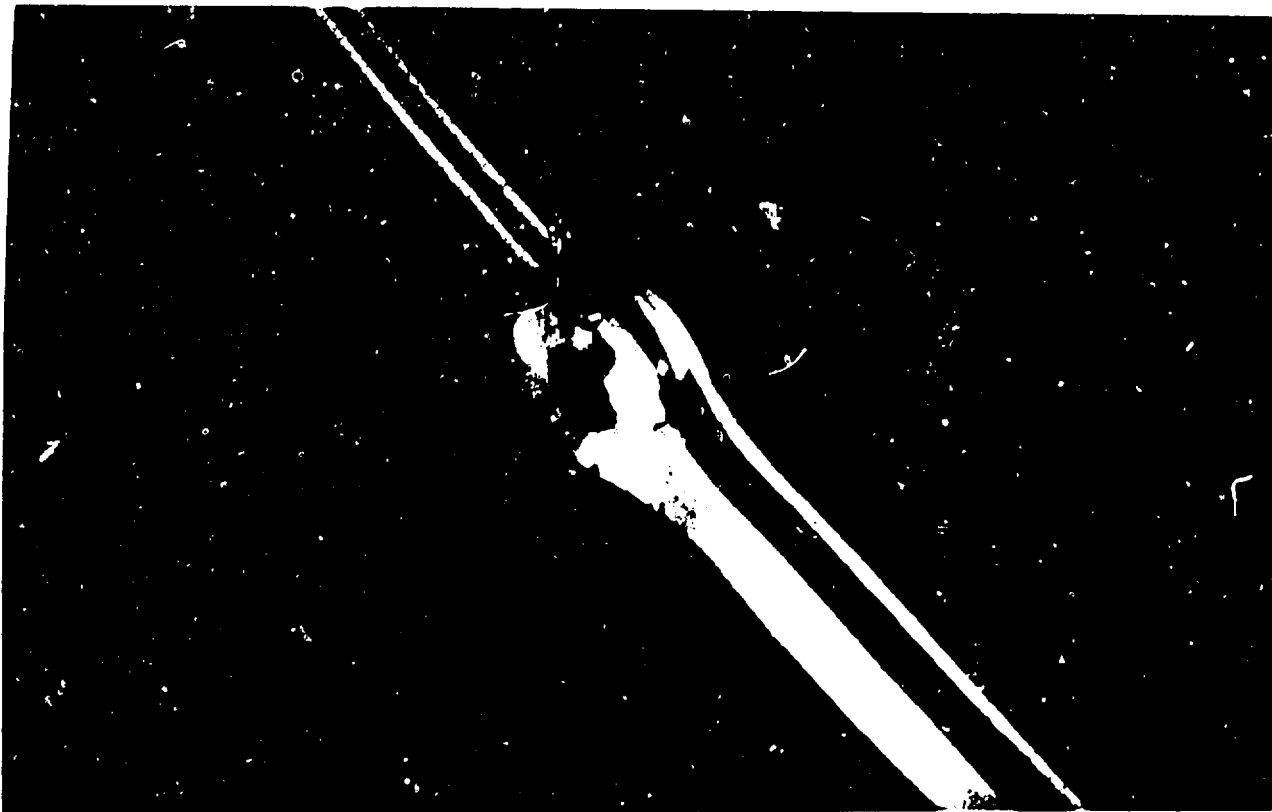
In test A, a small deliberate defect was introduced at the edge of the pinhole in model eyebar No. 330 in the location at which the pre-existent crack was found in the prototype eyebar. This deliberate defect was produced by a sawcut through the thickness of the bar at this point 1/32 of an inch deep, with a kerf width of 0.007 inches. It was subsequently sharpened to a fine crack by loading with a fluctuating load of 20,000 lbs., and was grown to a length of 0.020 inches prior to loading to failure. The failure load was provided by automatic control systems which increased the load linearly from a base loading of approximately 1/3 of the expected failure load to the capacity of the system or a specified maximum in about three seconds. The actual failure load for the model was 104,290 lbs., corresponding to a nominal unit stress in the shank of the eyebars of 55,400 lbs./sq. in. Stresses at the root of the fatigue crack were above the yield strength of the material. Events during the failure were photographed with a motion picture camera operating at 1,000 frames/second. Figures 29a and 29b show two of the critical stages of the joint separation. In Figure 29a the brittle fracture in the lower limb of the C13 head of model eyebar No. 330 has just occurred. In Figure 29b, which is 1021 frames later, the ductile fracture in the upper limb of this eyebar has been completed and eyebar No. 33 has just slipped off the opposite end of the pin.

**Figure 29a - Model Eyebar Test A at Instant of Brittle Fracture
in Lower Limb, Model Eyebar 330.**

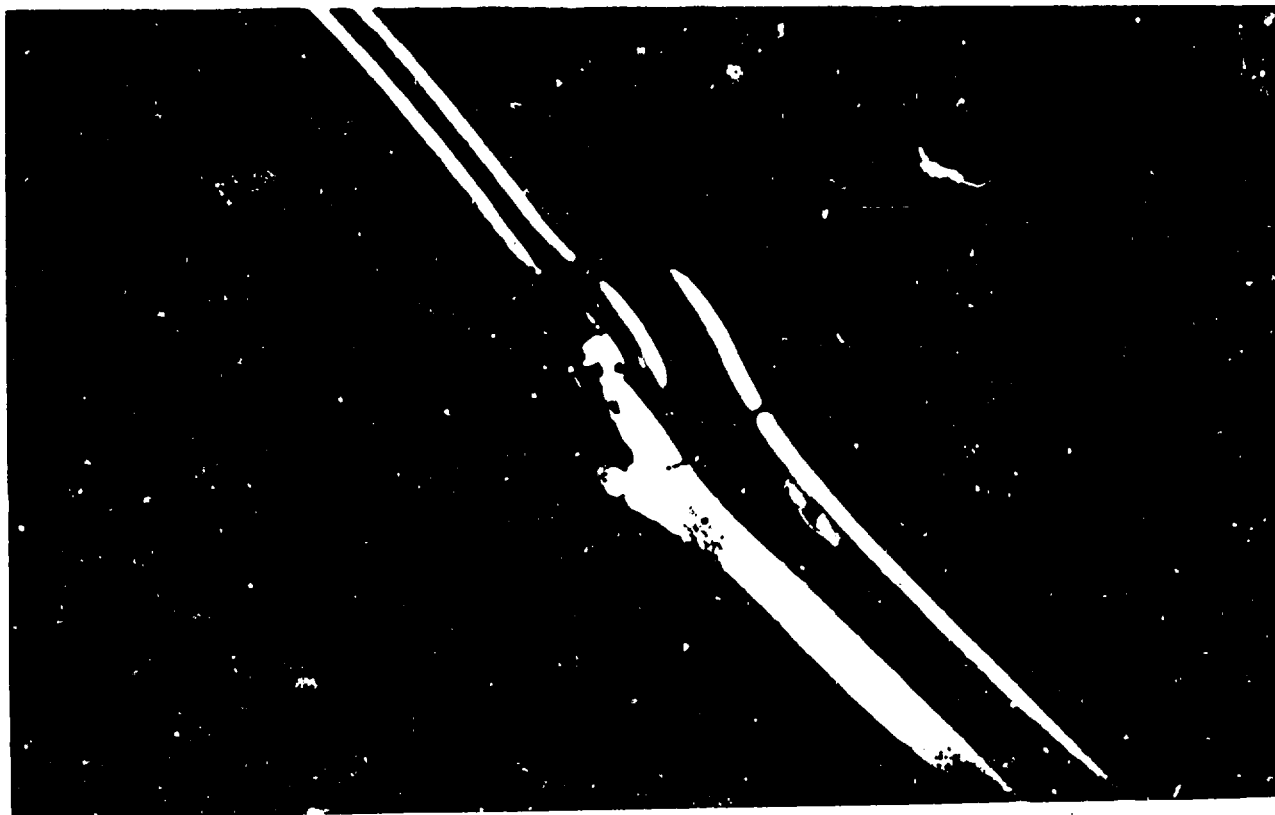
**Figure 29b - Model Eyebar Test A at Instant of Final Separation
of Model Eyebar 330. (This photo is 1,021 frames
later than Figure 29a; approximately 1.021 seconds later.)
(Federal Highway Administration Photos)**

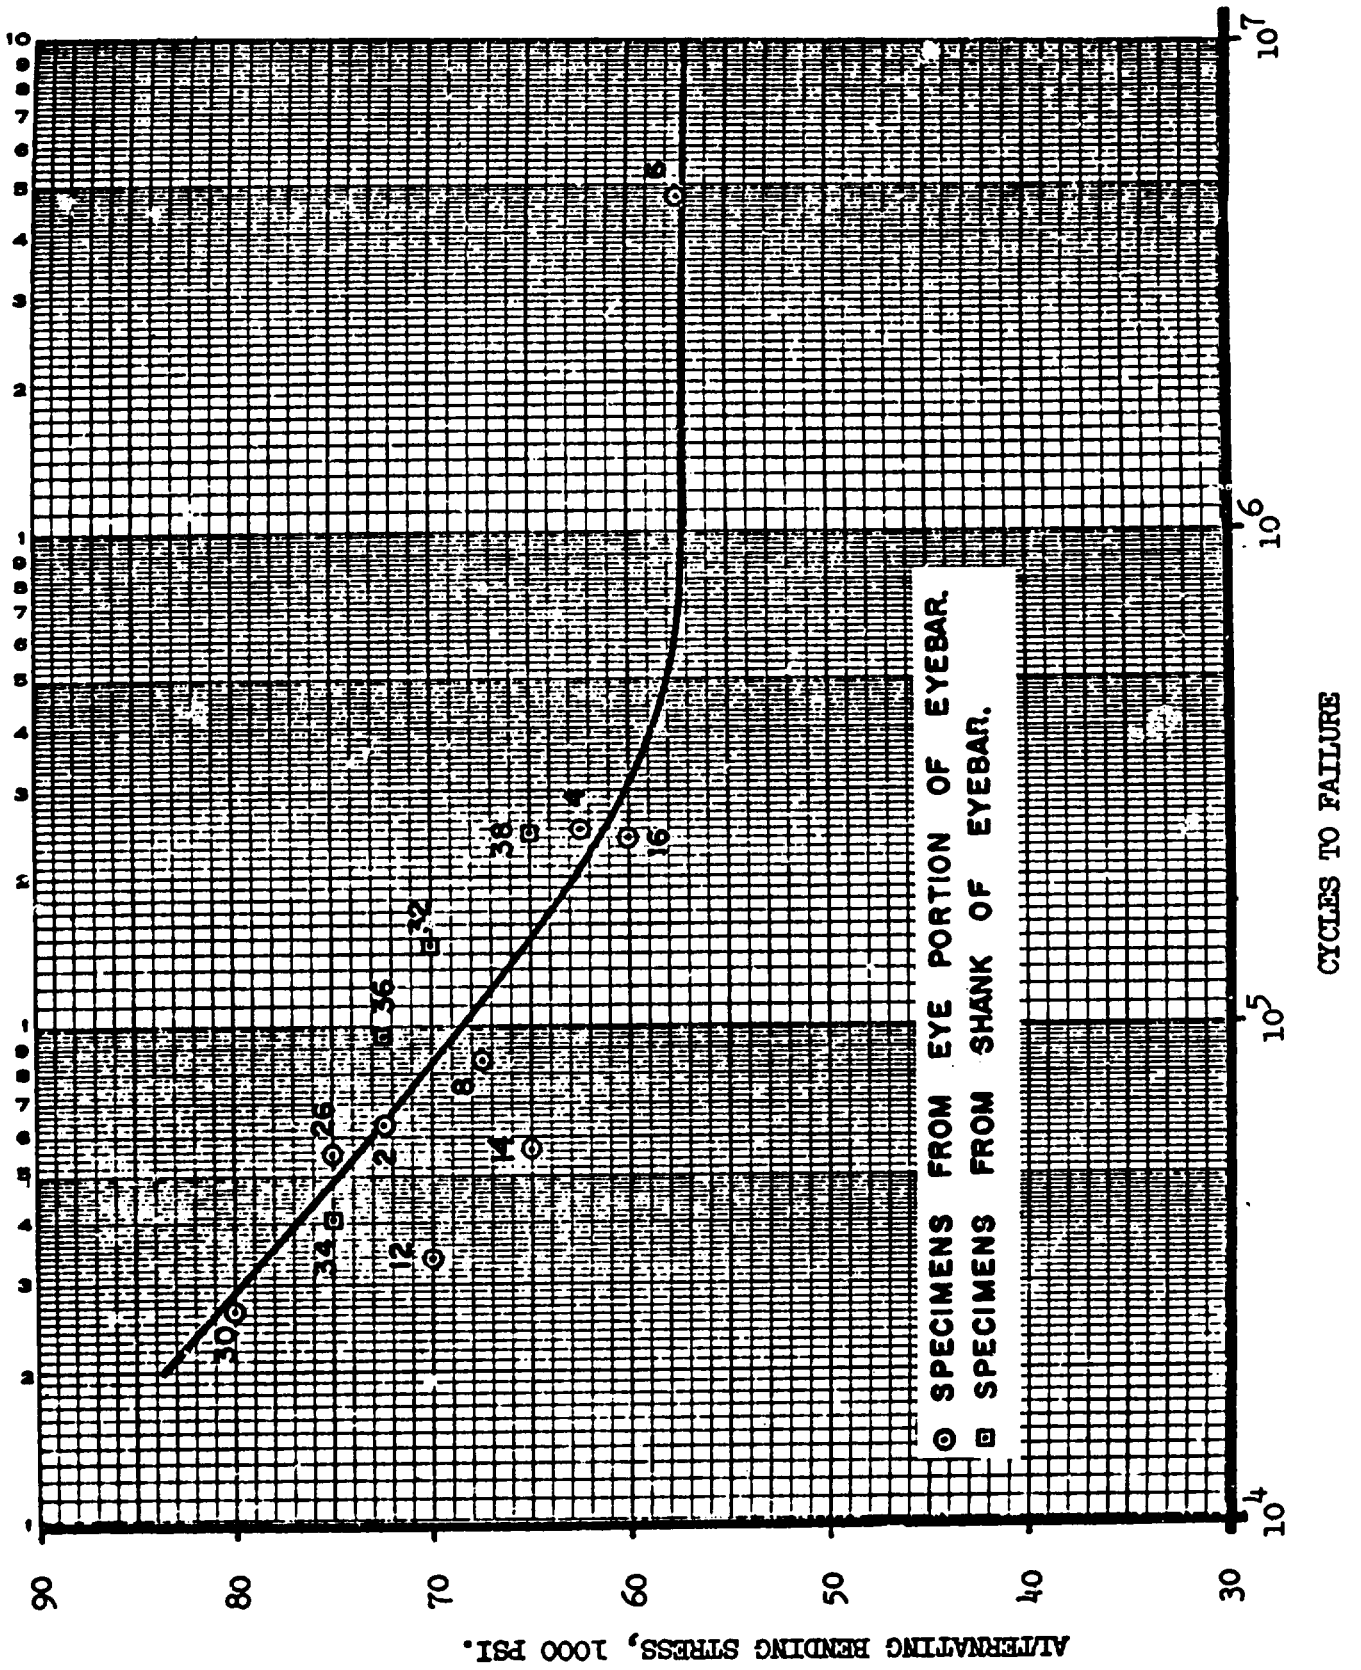
The results of these investigations, reported in February 1969 (Reference 29), show that the material of the eyebars was susceptible to fretting-fatigue, and that such action could reduce the fatigue life at a given stress range, as compared to rotating beam specimens of equal initial surface finish, by about 17 percent, as indicated by the S-N curves of Figures 31a and 31b. On a basis of these data, Professor Starkey estimated that the material in the critical location at the edge of the pinhole would have a life expectancy of about 200,000 cycles, assuming nominal stresses in the shank of the eyebar to vary from 40,000 psi. to 50,000 psi. and considering the effects of stress concentration and fretting. However, he also pointed out that the presence of water in the joint would contribute further to the acceleration of fatigue damage by the mechanism of corrosion-fatigue, possibly reducing the life by as much as 50 percent, thus approaching the 73,000 cycles would correspond to five cycles per day for 40 years. Professor Starkey concluded his report with the observation that the static proof tests of the eyebars did not relate in any way to the ability of the bar to sustain the high local stresses in the head over a long period of time and under variations of load.

Figure 31a - Results of Rotating Beam Fatigue Specimens Tested by W. L. Starkey

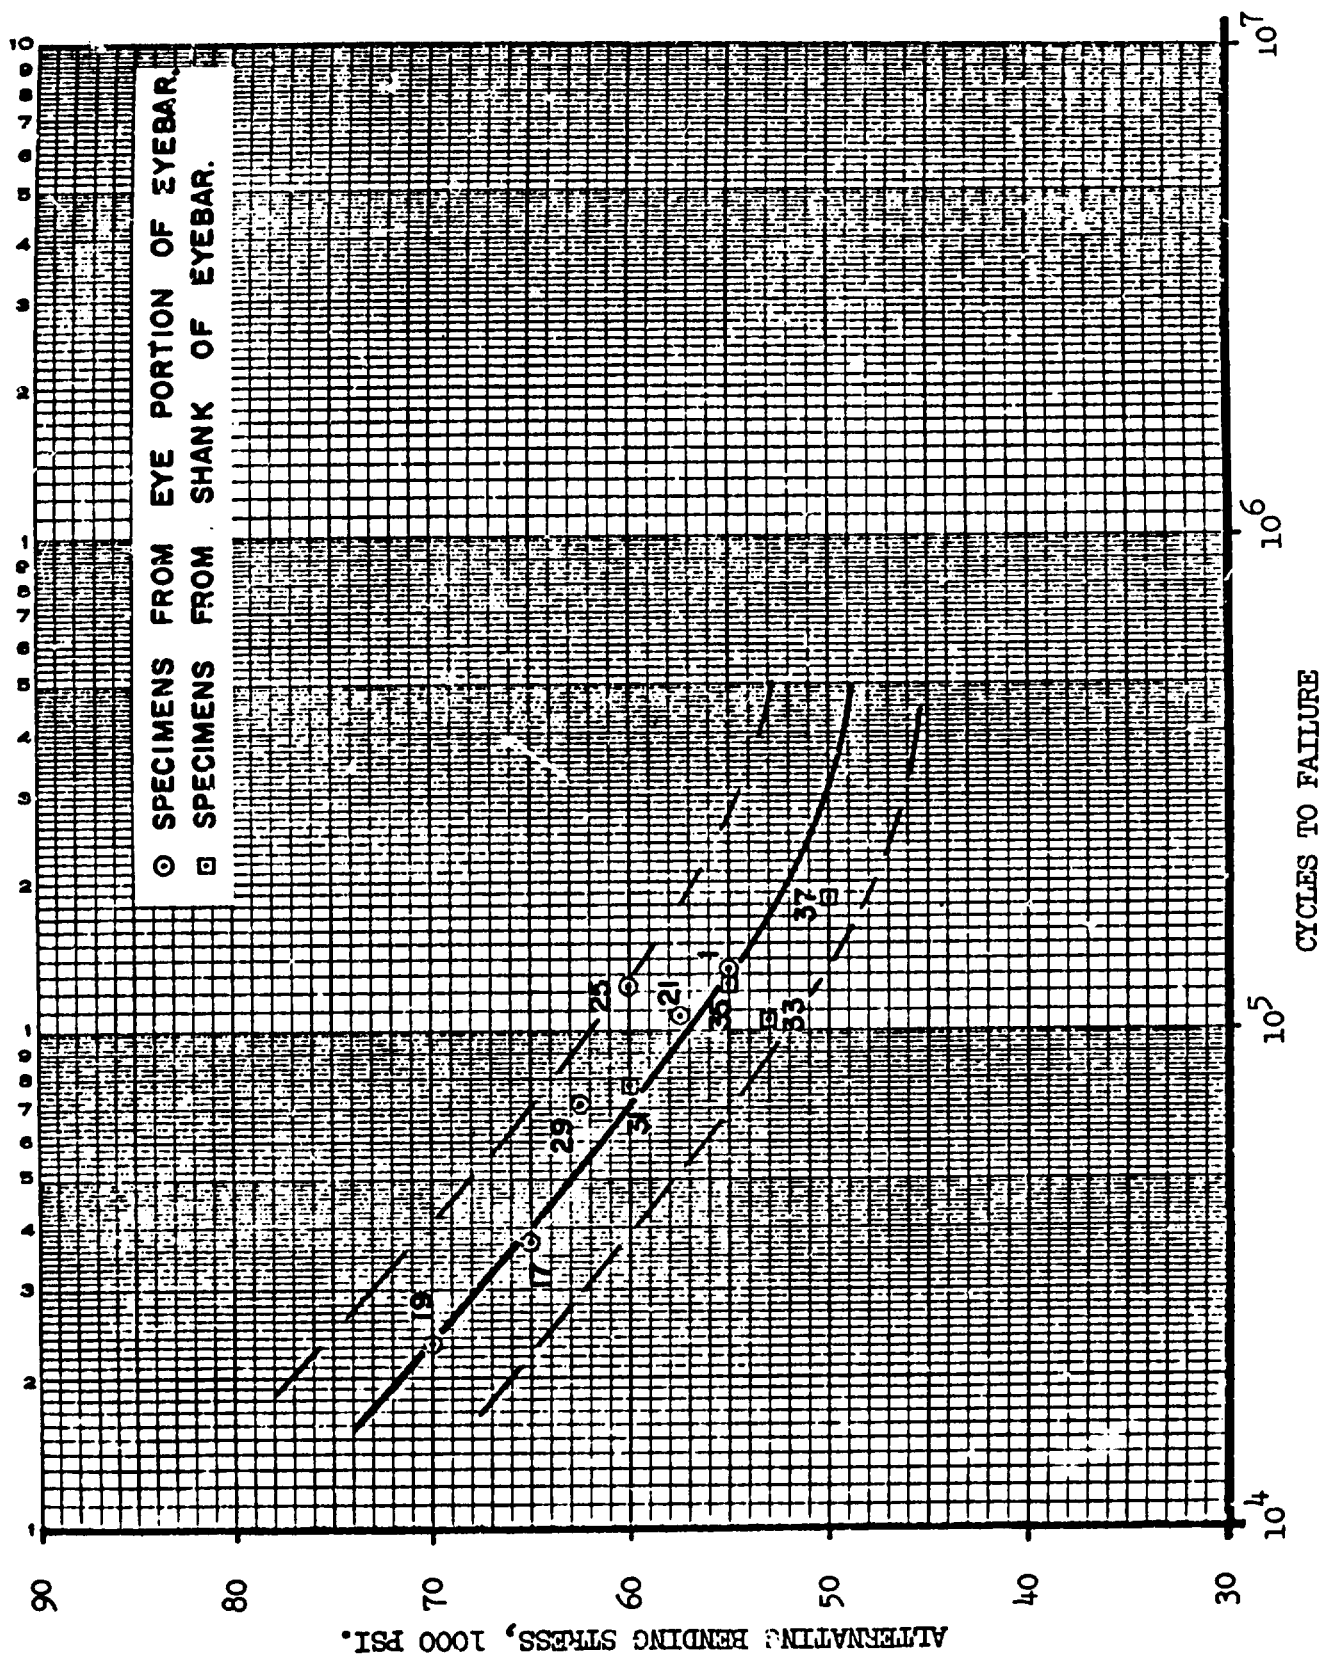
Figure 31b - Results of Fretting Fatigue Specimens Tested by W. L. Starkey
