HIGHWAY ACCIDENT REPORT

**COLLAPSE OF U. S. 35 HIGHWAY BRIDGE,
POINT PLEASANT, WEST VIRGINIA
DECEMBER 15, 1967**

**NATIONAL TRANSPORTATION SAFETY BOARD
Washington, D. C. 20591
REPORT NUMBER: NTSB-HAR-71-1**

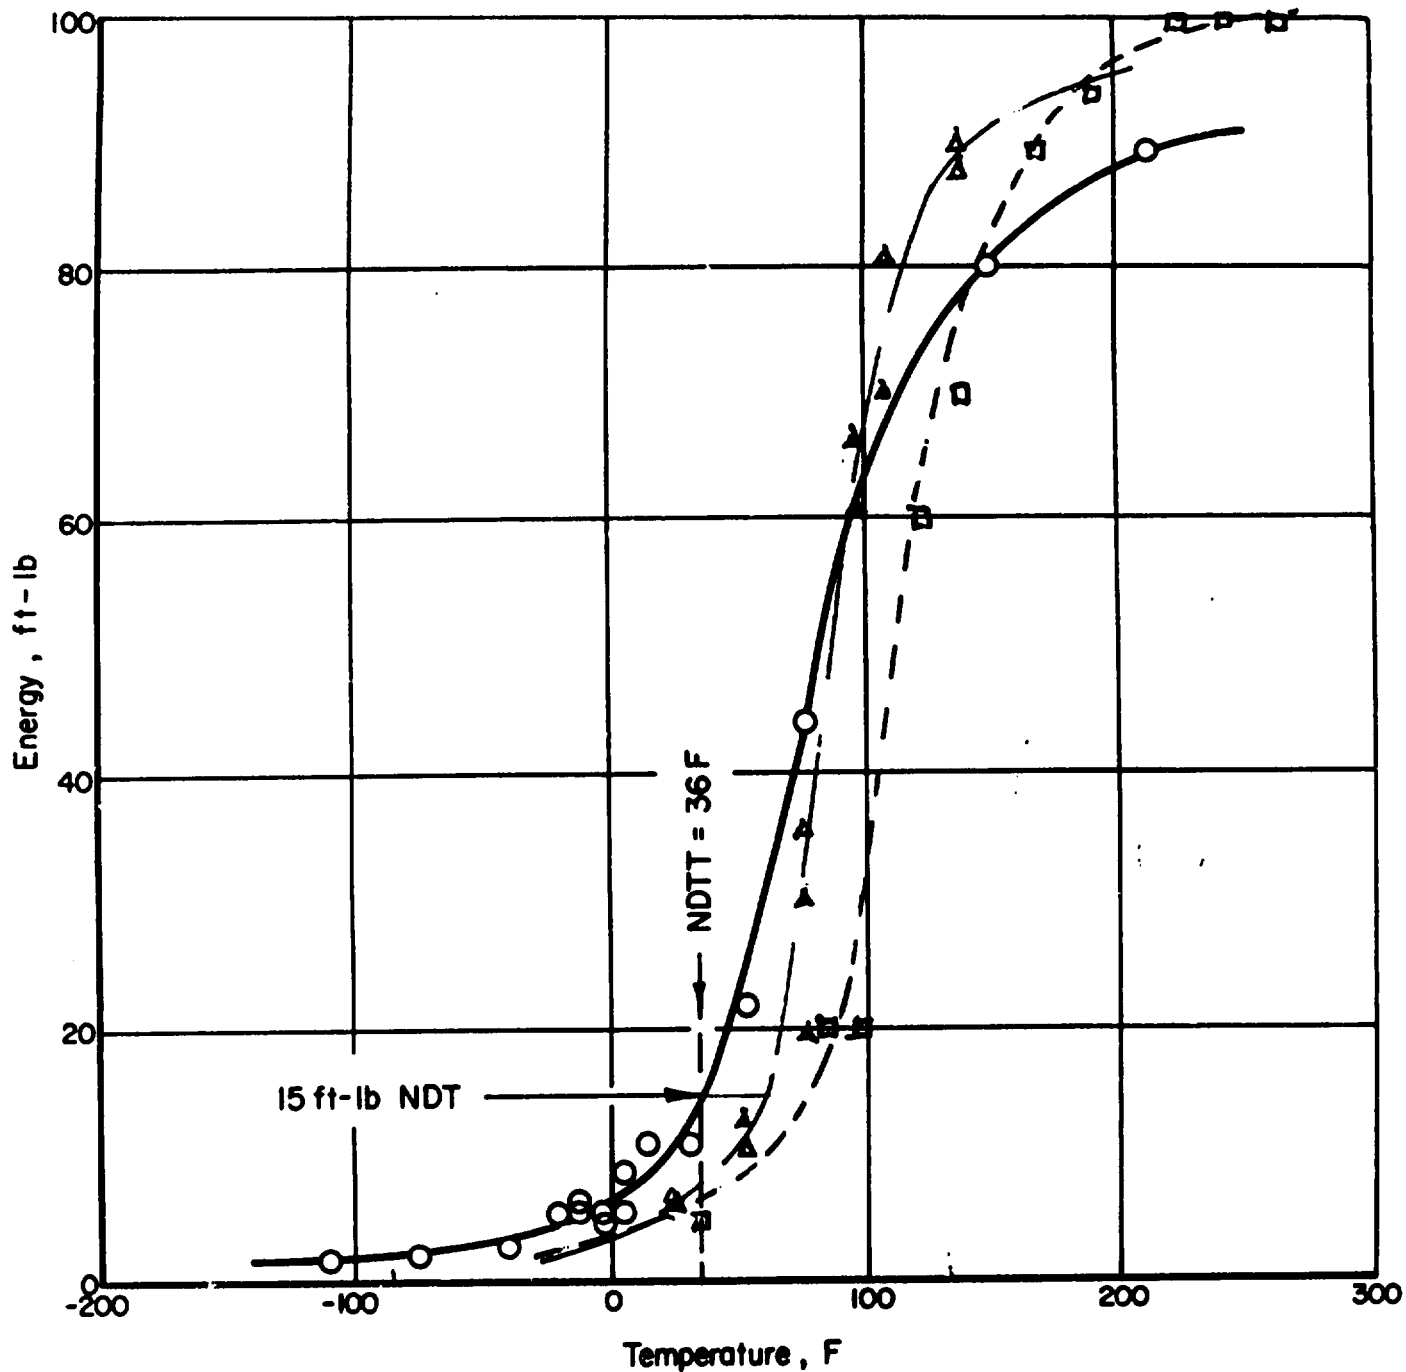
Regardless of the differences in the data from the various laboratories, it is apparent that the A7-24 steel in this structure, when at the 32°F. temperature which existed at the time of collapse, was operating below its transition temperature. At this temperature, all of the laboratories obtained Charpy values below 10 foot pounds, with an average of about 7 foot pounds. This would indicate that the steel at this temperature had low energy absorption capacity for loads applied at high strain rates compared to that exhibited at room temperature or above. The instrumented Charpy tests conducted by Battelle

Figure 32 - Comparison of Charpy Impact Data for A7-24 Type Steel from Chain Bent Posts Obtained by Participating Laboratories

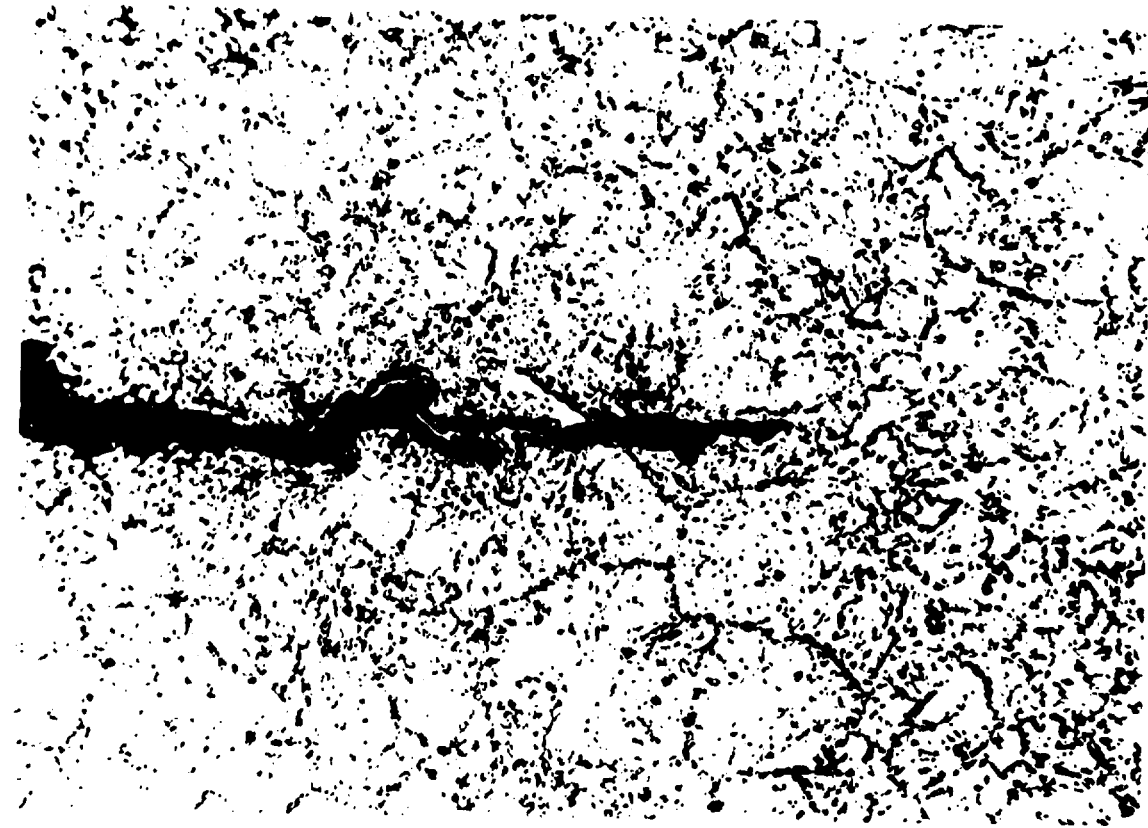
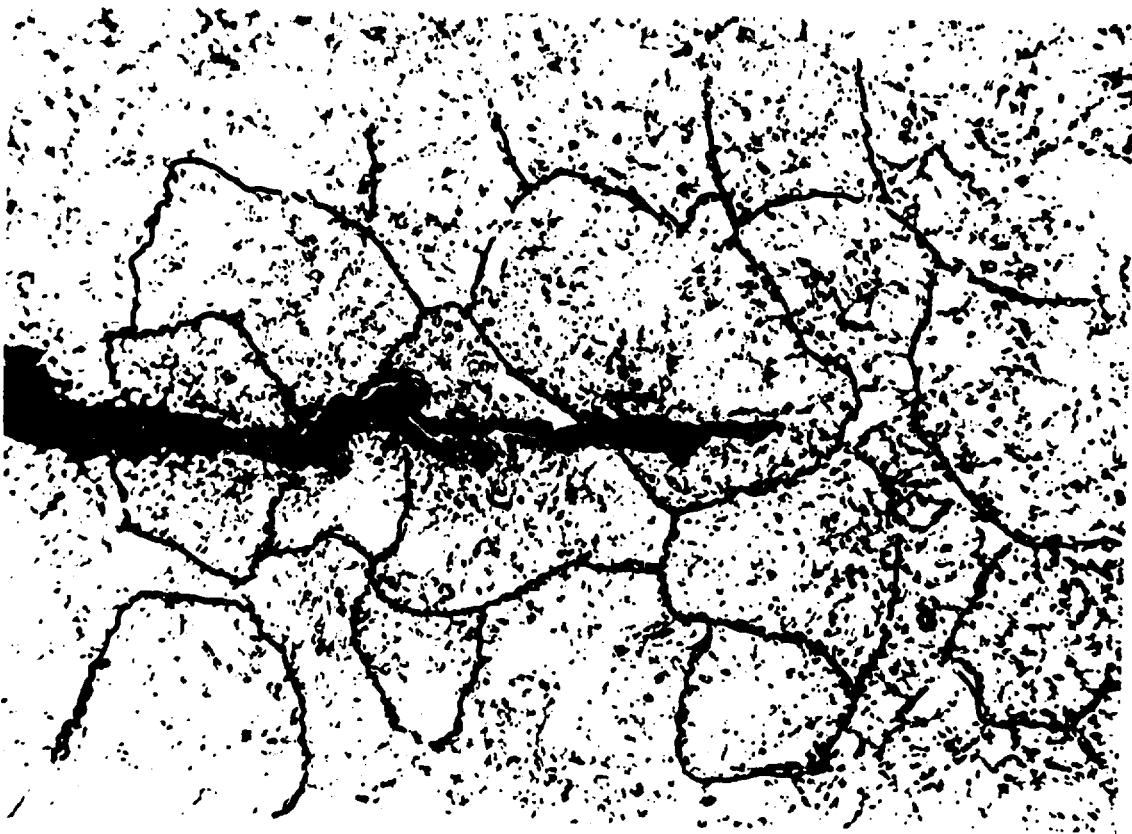
Subsequent to this report, the U. S. Steel laboratory used a special picric acid etch to bring out the grain boundaries more clearly in a portion of the fracture in eyebar No. 330. An example of the result is shown in Figure 33a and 33b. In the right photograph, the appearance of the specimen after etch is shown. In the left photograph, the grain boundaries detected by the investigator have been marked on an overlay. This crack is clearly transgranular rather than intergranular, favoring the mechanism of corrosion-fatigue.

(b) Crack Appearance after Extended Picral Etch
(x 500)

(a) Probable Grain Boundary Lines Superimposed

Figure 33 - Relationship of Crack Propagation of Secondary Crack in Eyebar No. 330 to Grain Boundaries
(U. S. Steel Photo)

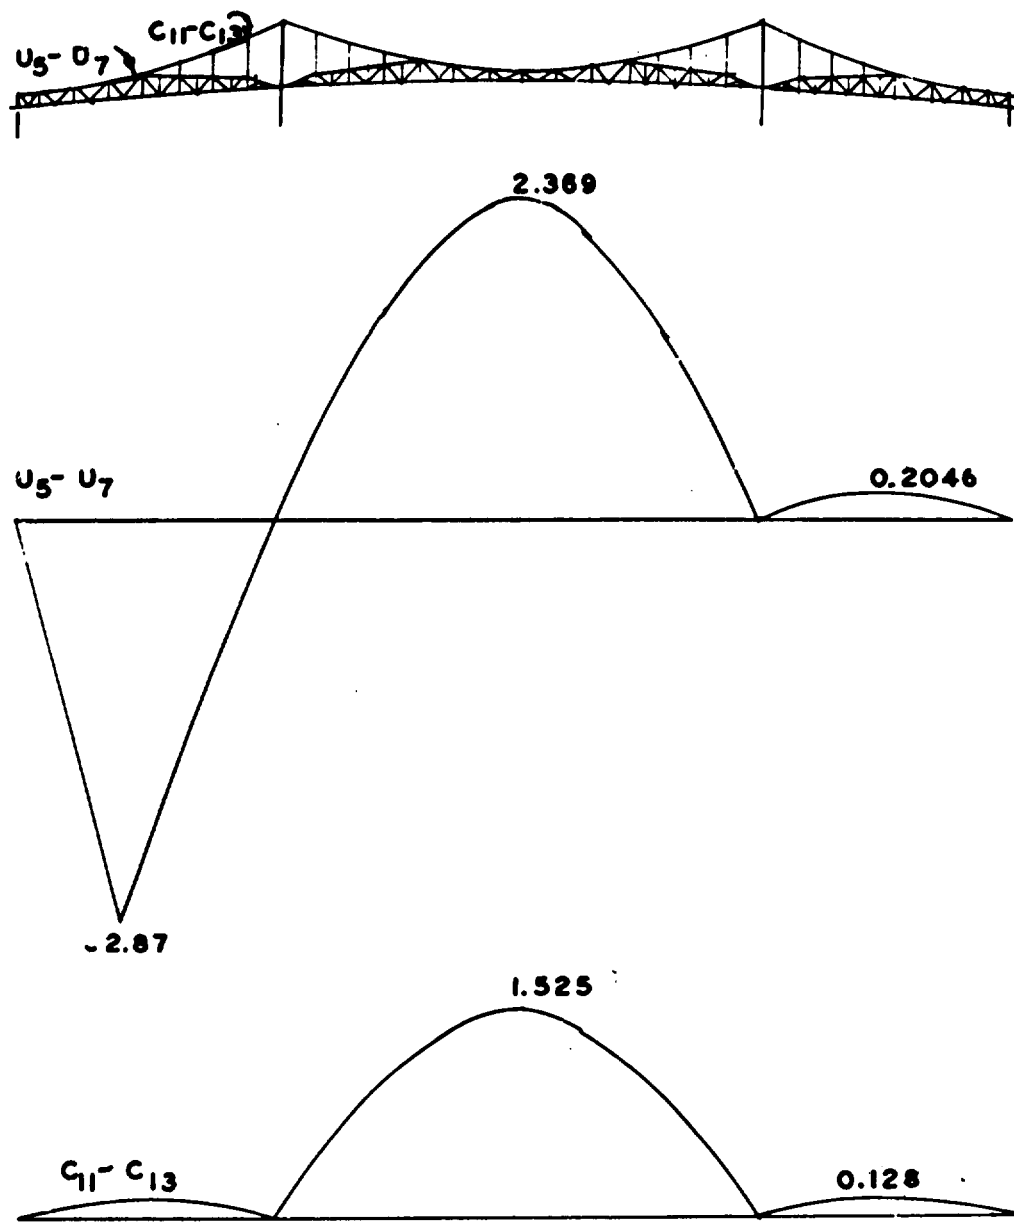
Loadings which did not extend very far into the center span produced even greater differences in stress range. Moreover, trains of vehicles which move continuously across the structure while maintaining a total length about equal to the length of the main span would produce approximately 85 percent of maximum range (495 kips) in C11-C13, but 96 percent of maximum range (120 kips) in U5-U7. Thus it would appear that the general range of stress in U5-U7 would be about twice that of C11-C13 for any given probability of occurrence. This would reduce the fatigue life by a factor of ten or more, or in other words, make the occurrence of a fatigue fracture in U5-U7 ten times more probable.

It therefore appears that the stress-corrosion was the dominant mechanism, in spite of the fact that there is evidence

Fig. 34 INFLUENCE LINES FOR $U_5 - U_7$, $C_{11} - C_{13}$
